# **INDOOR AIR QUALITY ASSESSMENT**

**Lowell High School  
Freshman Academy  
40 Paige Street  
Lowell, MA**

Prepared by:  
Massachusetts Department of Public Health  
Bureau of Environmental Health  
Indoor Air Quality Program  
August 2017

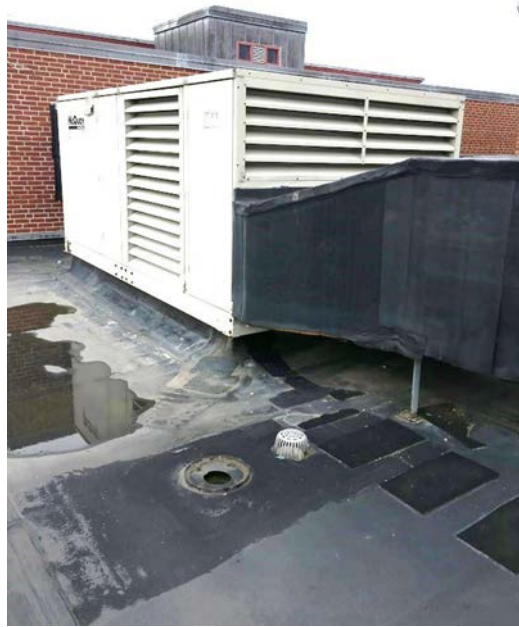
**Picture 1**

Ventilation for the Freshman Academy is provided by a single air-handling unit (AHU) located on the roof (Picture 1). Fresh air is distributed via ductwork connected to ceiling or wall-

**Rooftop air handling unit (AHU)**

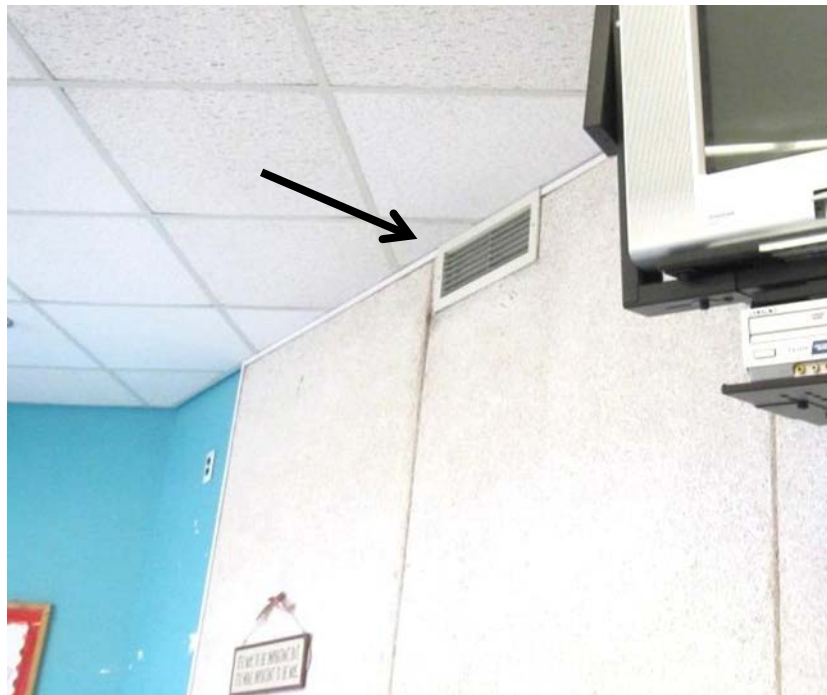
**Picture 2**

mounted diffusers in classrooms (Pictures 2 and 3). The amount of fresh air drawn into the units is controlled by moveable louvers connected to an activator motor to alter fresh air intake to help maintain temperature. Exhaust ventilation is provided by ceiling or wall-mounted grates that return air back to the AHU via ductwork.

**Wall-mounted supply diffuser (arrow)**

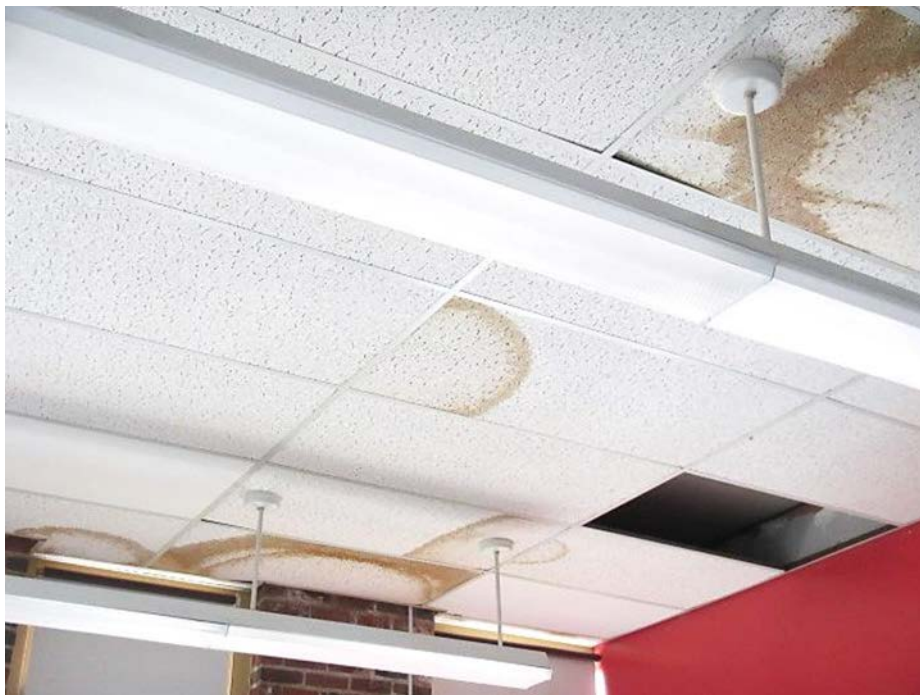
**Picture 4**

Water-damaged ceiling tiles and ceiling plaster were observed in some classrooms, offices, and hallways (Pictures 4 through 6; Table 3). Such damage indicates leaks from the building envelope or plumbing system. Water-damaged ceiling tiles should be replaced after the leak is found. In general, ceiling tiles have an open space above them (the ceiling plenum) and tend to dry out quickly, reducing the chance for mold colonization. Ceiling plaster does not contain organic material; therefore, it will not support microbial growth even when frequently moistened. In some cases, dust or paint on the surface of plaster can become mold colonized. If this occurs, plaster can often be cleaned to remove the mold.

**Water-damaged and missing ceiling tiles**

6. Consider working with a roofing contractor to examine methods of pitching roof towards drains to prevent water pooling.
7. Ensure roof and plumbing leaks are repaired and replace water-damaged ceiling tiles.

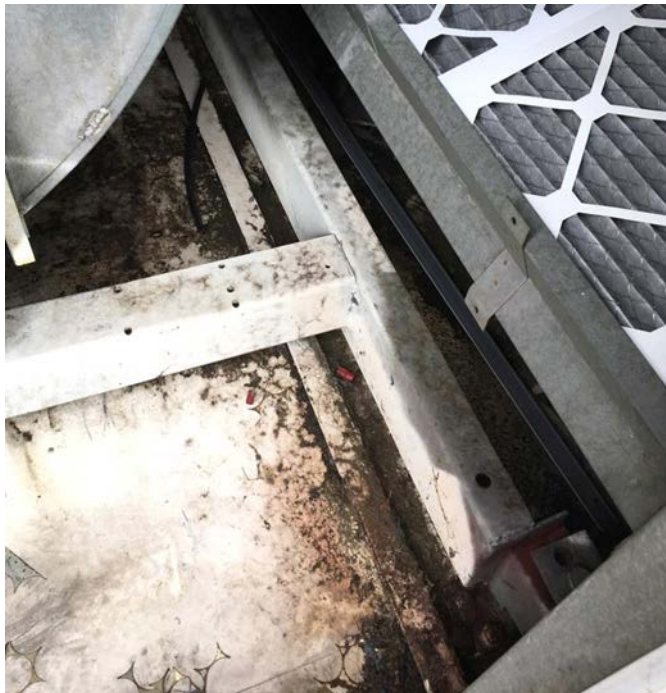
**Picture 16**

Filters for the AHU should be changed in accordance with manufacturer's instructions (e.g., two to four times a year). The MDPH recommends pleated filters with a Minimum Efficiency Reporting Value (MERV) of 8, which are adequate for filtering out pollen and mold spores (ASHRAE, 2012). Note, although the AHUs appeared to have good/pleated filters, the interior of the units had accumulated dust/debris (Pictures 15 and 16) and should be cleaned out thoroughly (e.g., during regular filter changes).

**Dust/debris accumulation inside AHU**

12. Use pleated filters of MERV 8 in AHUs, if these can be used with the current equipment. Ensure filters are changed 2 to 4 times a year. Thoroughly clean inside of AHU cabinets during filter changes.
